## PICTURE REFERENCES SAMPLE

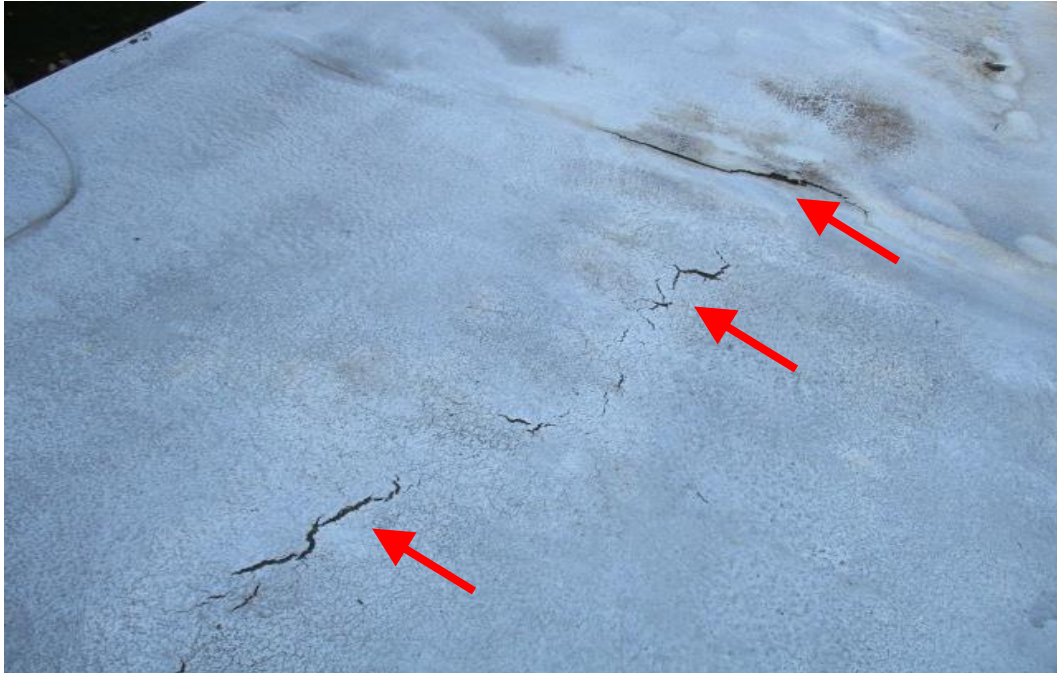
Picture 1

The flat roof areas over the Arizona room and back patio are in poor condition.

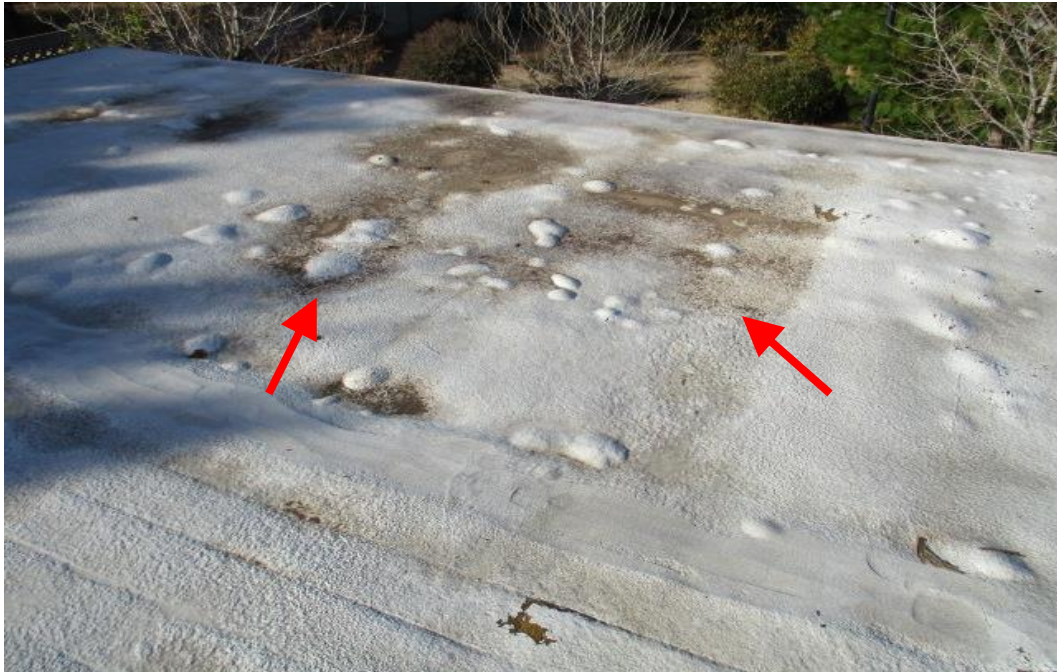
Picture 2

The flat roof areas over the Arizona room and back patio are in poor condition.

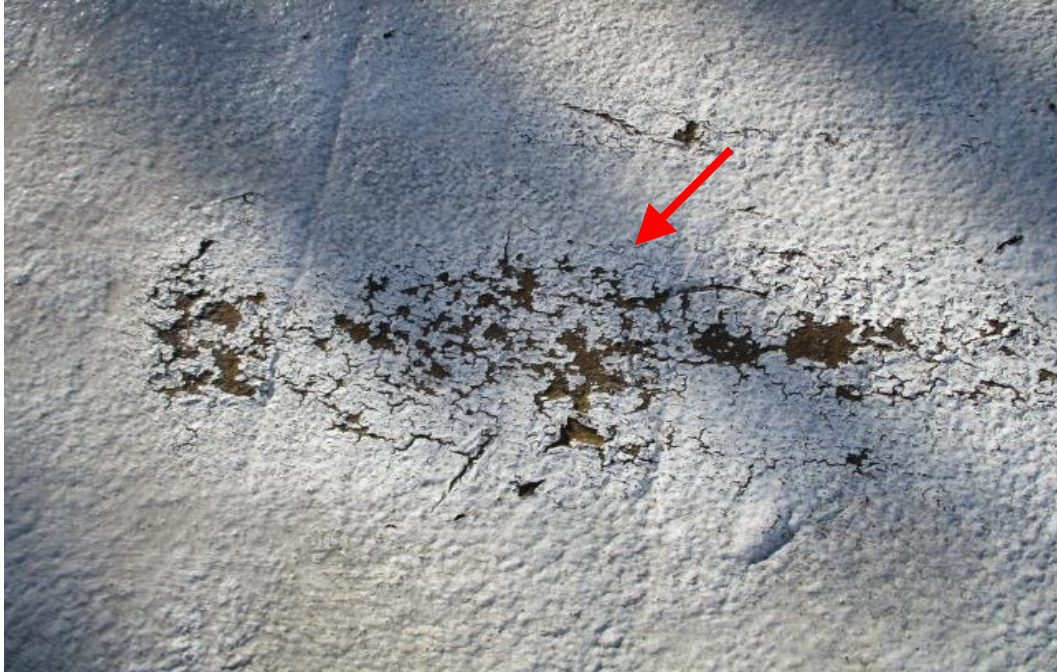
Picture 3

The flat roof areas over the Arizona room and back patio are in poor condition.

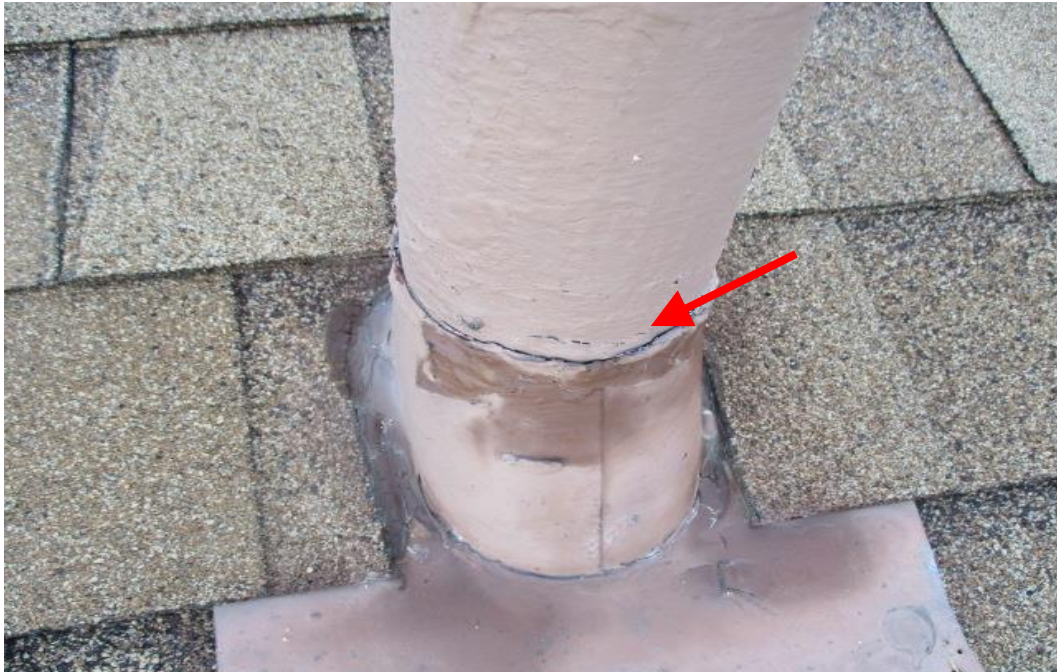
Picture 4

There is a crack in the seal around the water heater vent pipe.

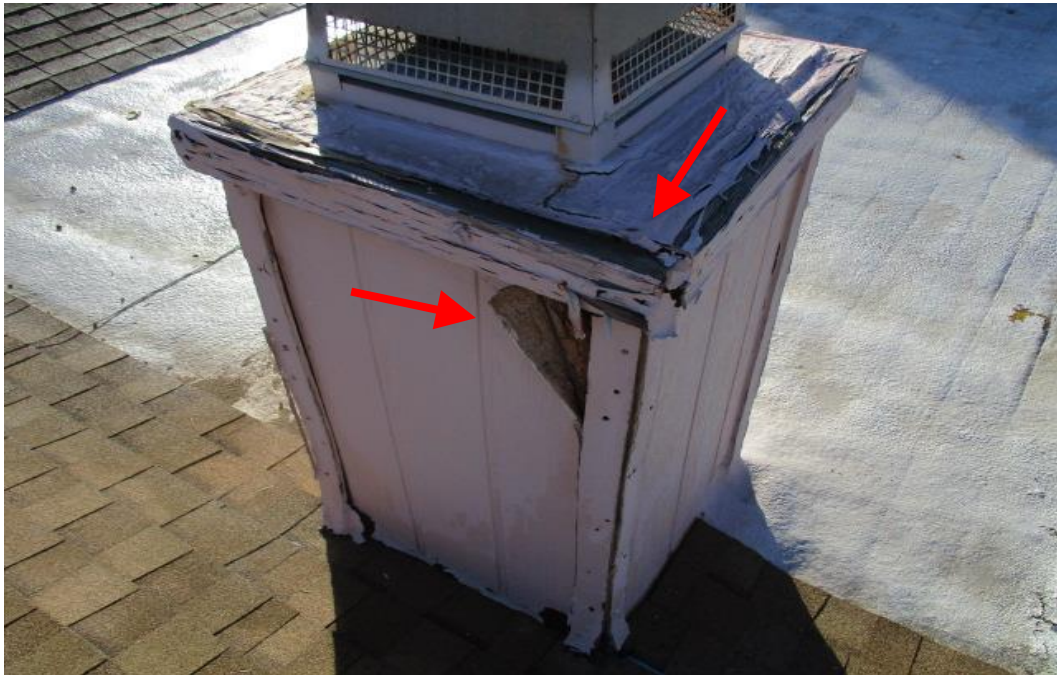
Picture 5

The wood around the chimney is in poor condition.

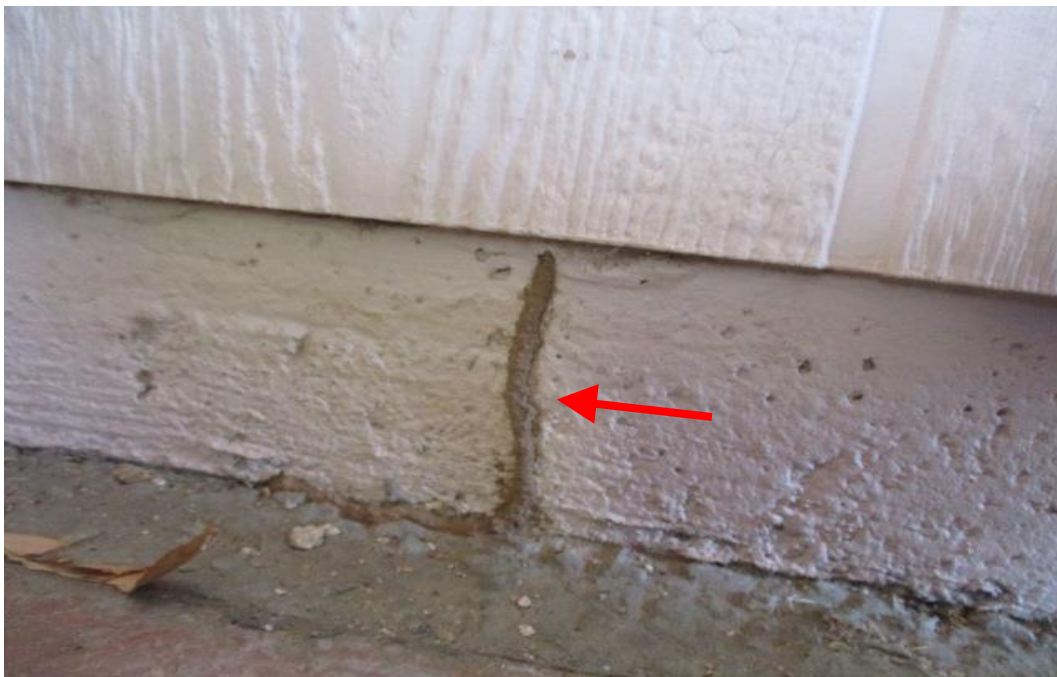
Picture 6

There are termite tubes on the back patio.

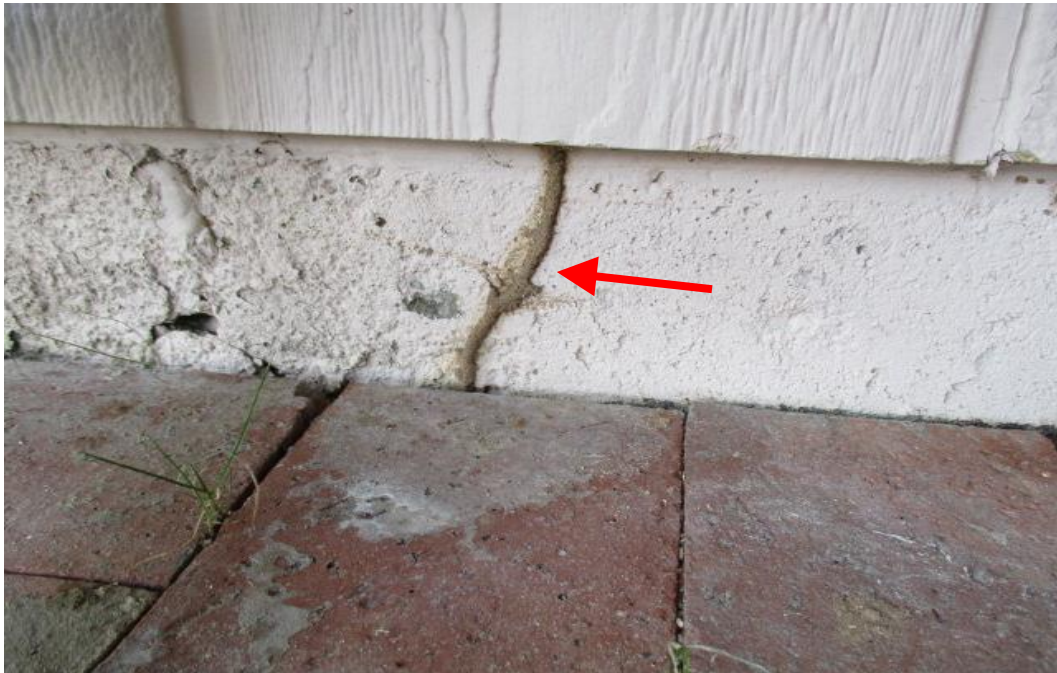
Picture 7

There are termite tubes on the back patio.

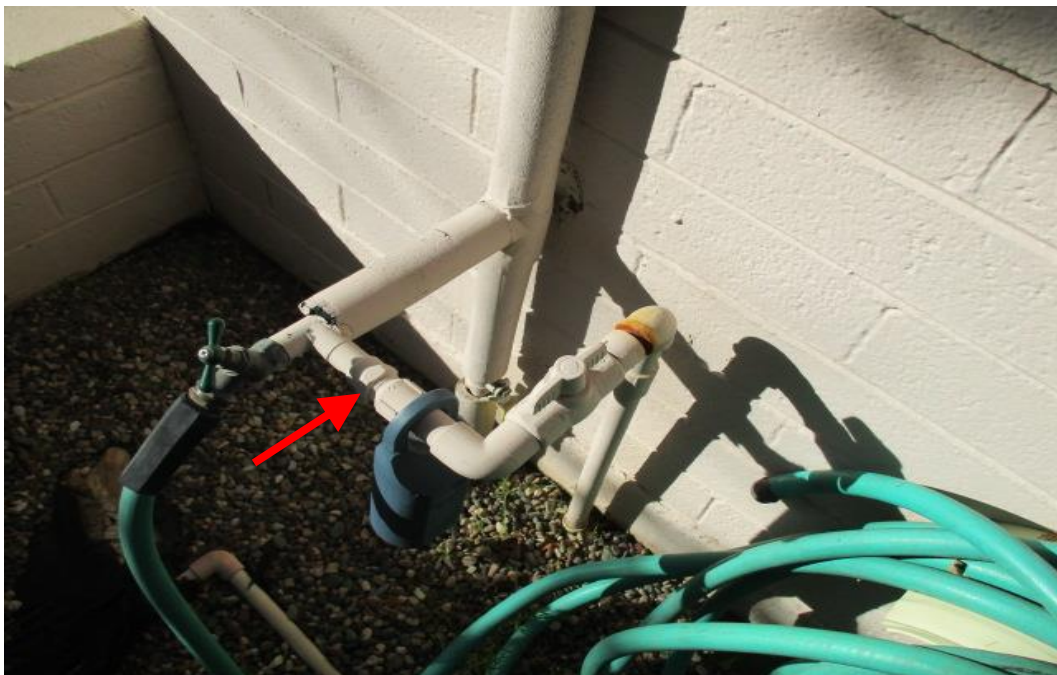
Picture 8

There is no vacuum breaker where the landscape watering system connects to the water main.

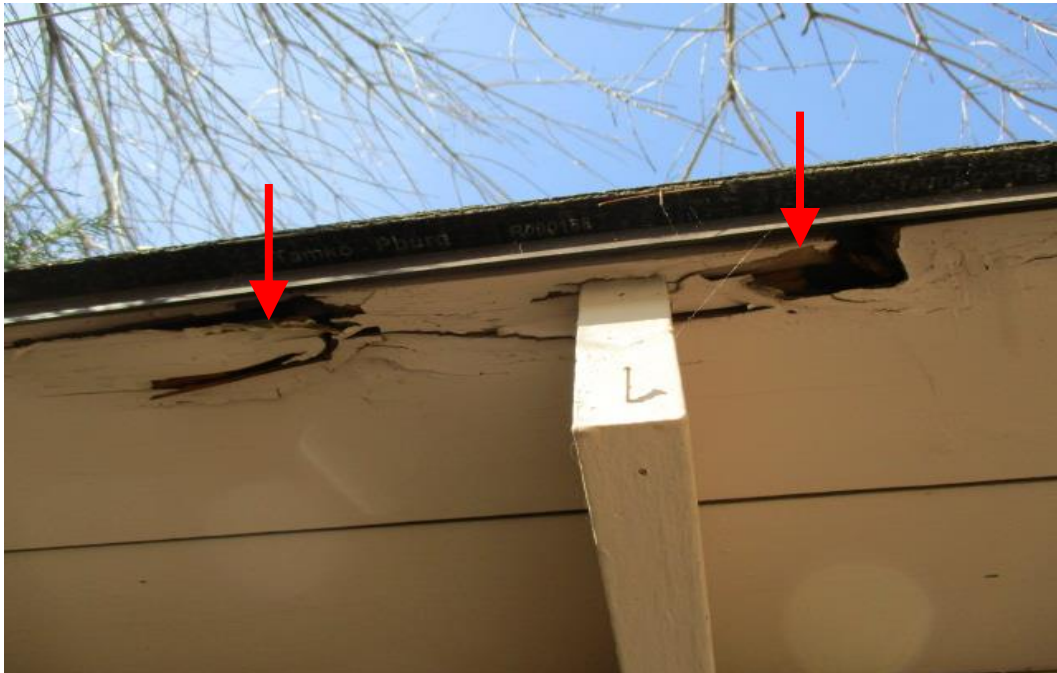
Picture 9

There is damaged wood at the roof below the front of the carport.

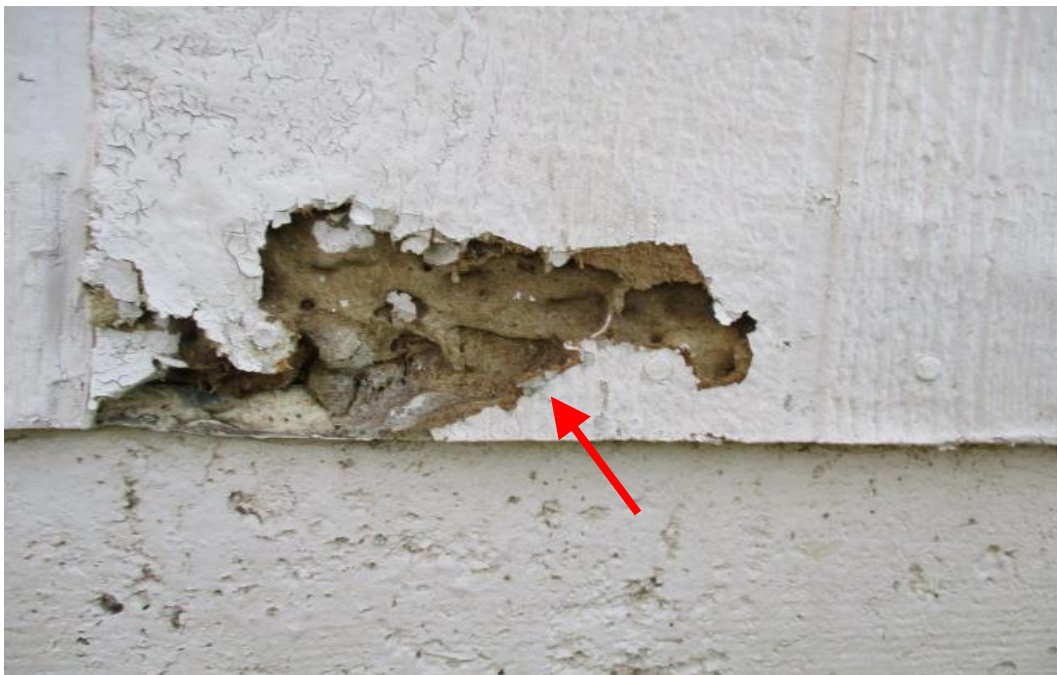
Picture 10

There is damaged siding at the back of the house.

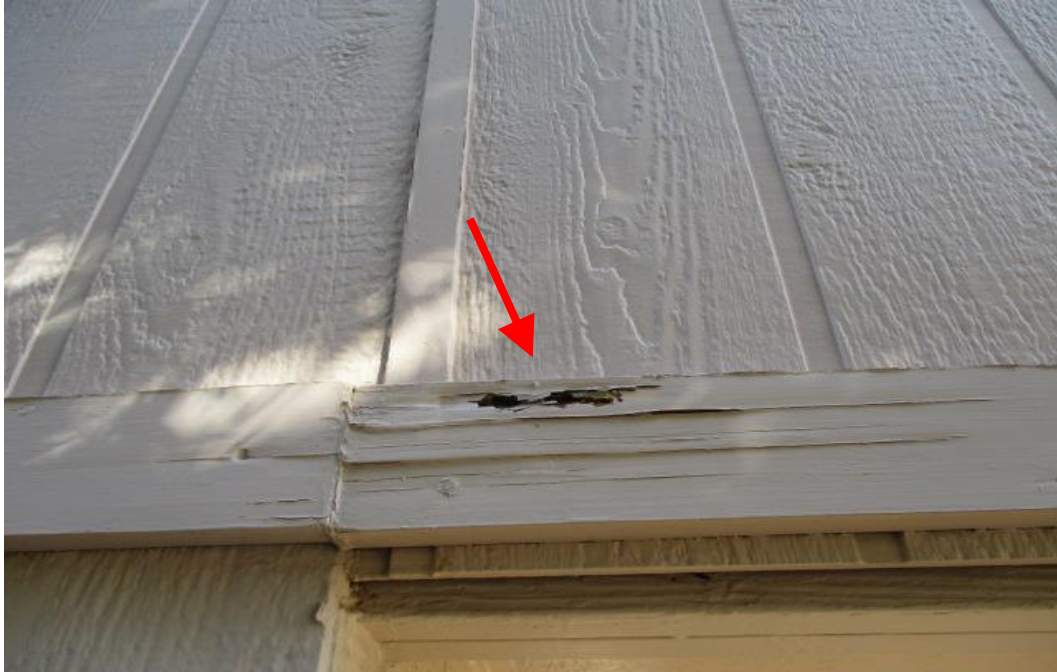
Picture 11

There is damaged wood trim at the side of the carport.

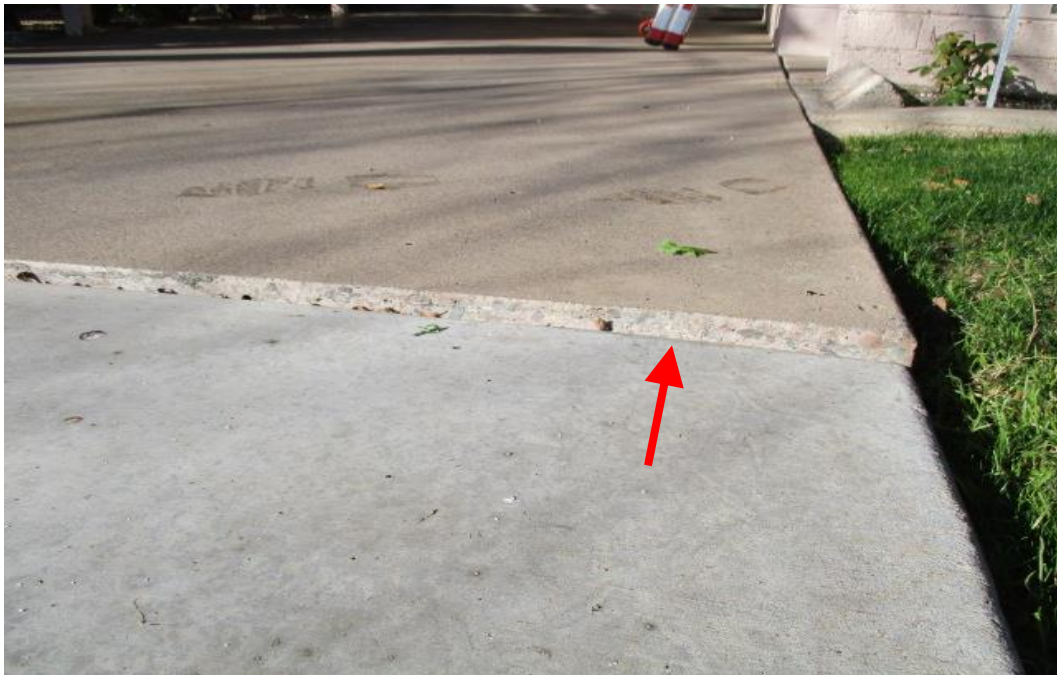
Picture 12

There is an off-set in the driveway that could be a trip hazard.

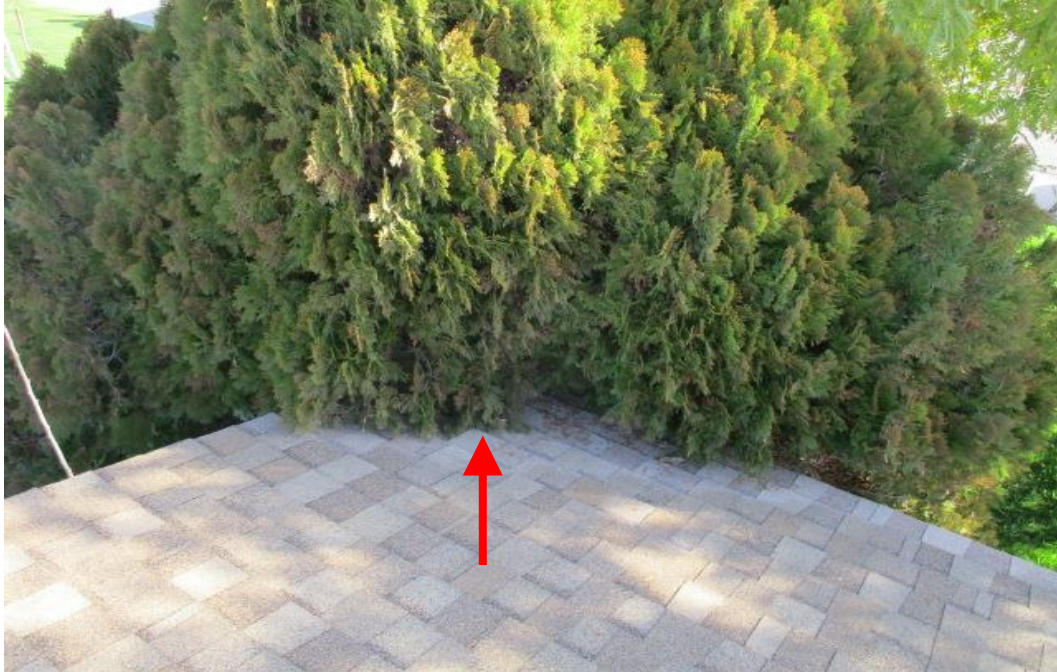
Picture 13

There is vegetation overgrowing the walls/roof.

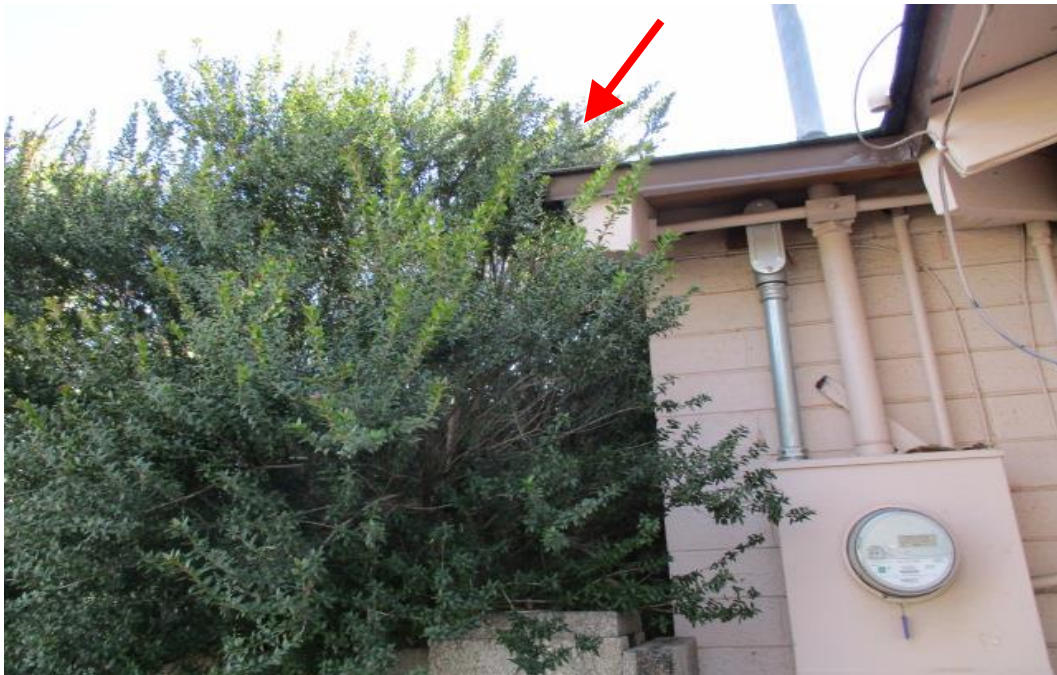
Picture 14

There is vegetation overgrowing the walls/roof.

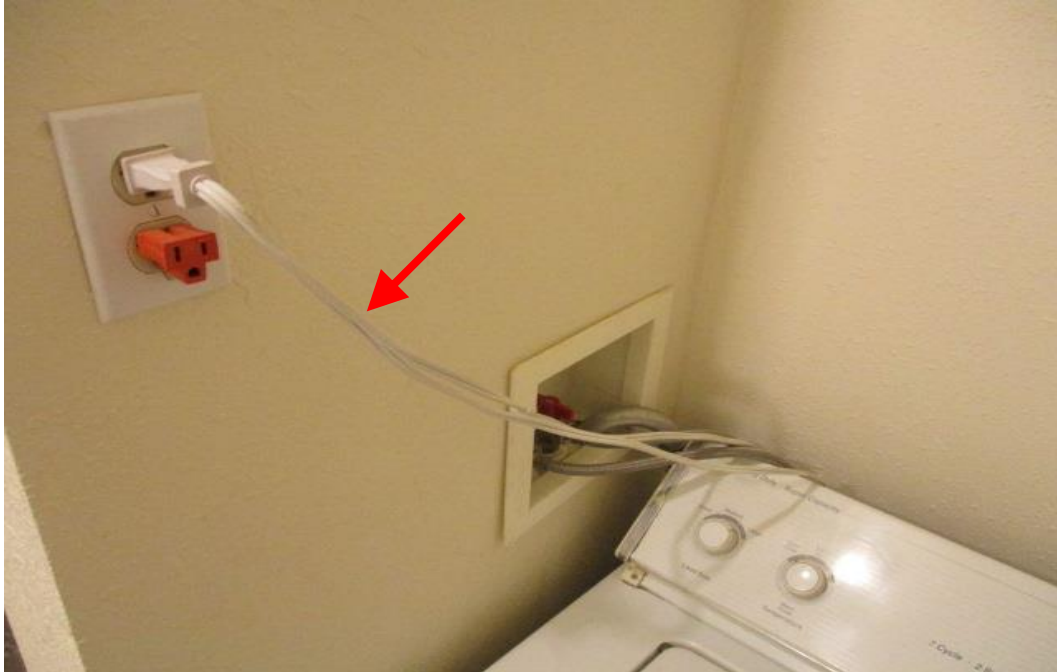
Picture 15

The washer and dryer are powered with an extension cord.

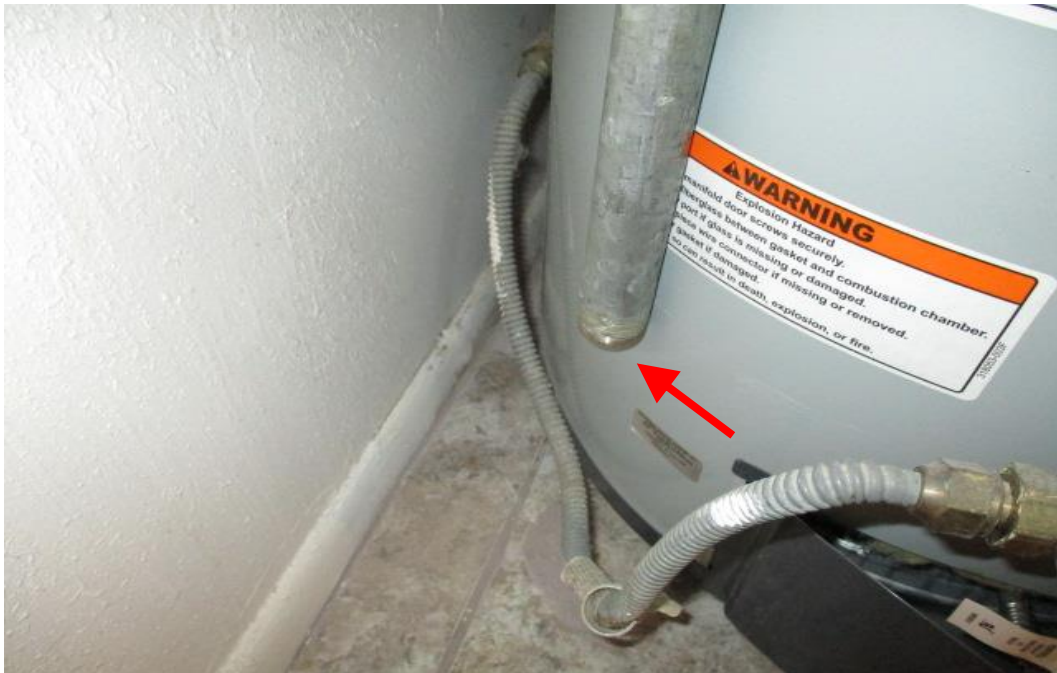
Picture 16

The water heater pressure relief drain line terminates in the laundry room.

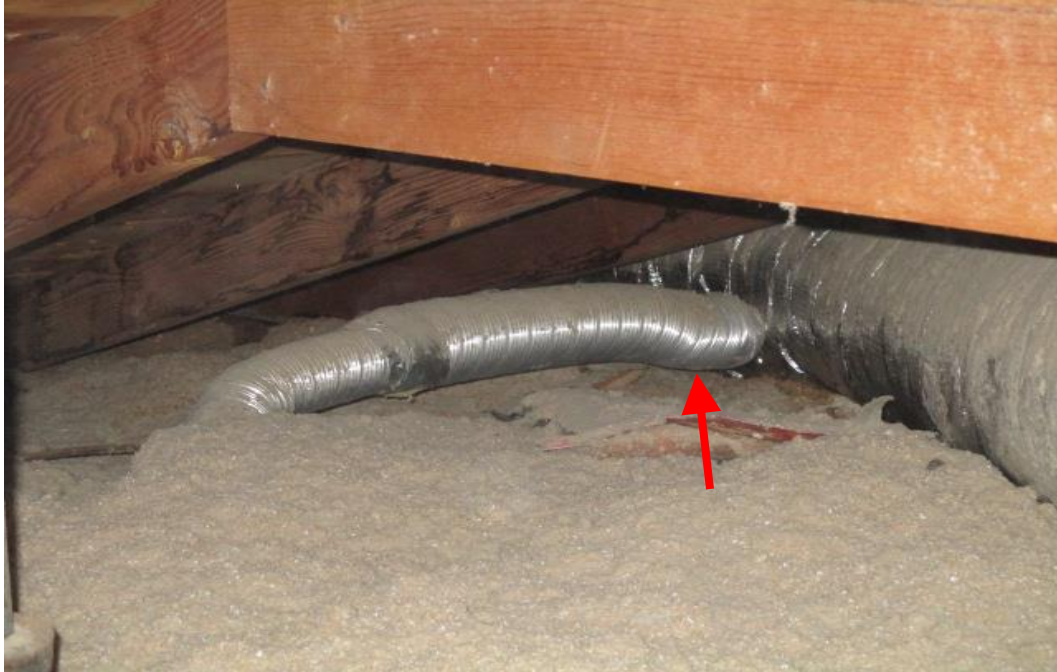
Picture 17

It appears the duct for the hallway bathroom exhaust fan terminates in the attic.

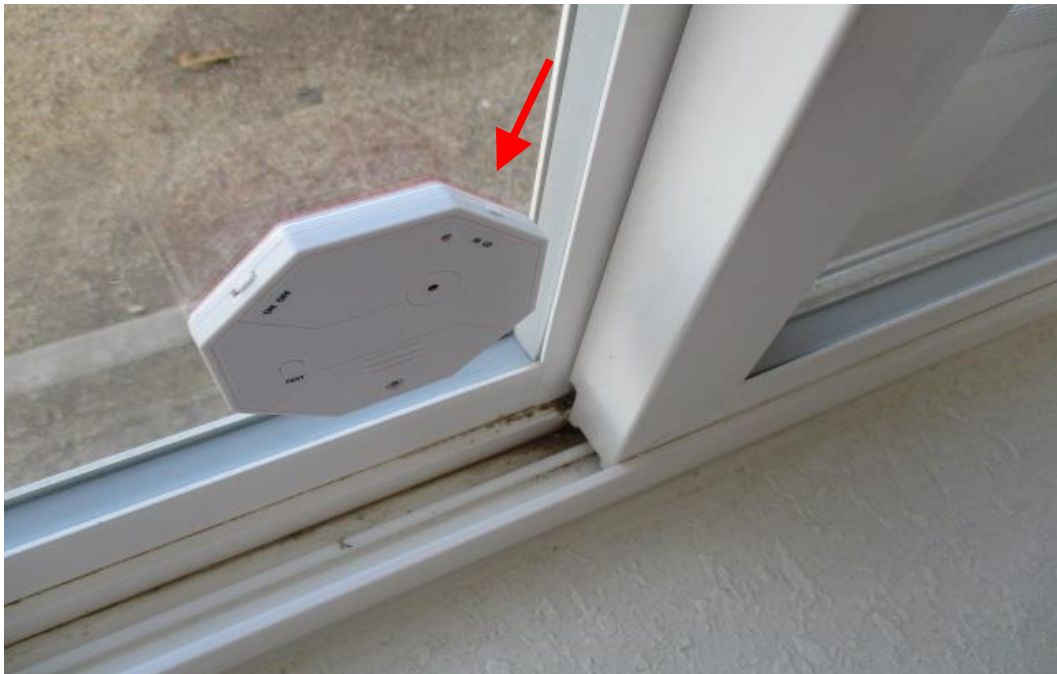
Picture 18

The security system component installed on the master bedroom window blocks the window from being opened.
